**NASA TECHNICAL  
MEMORANDUM**

REPORT NO. 53882

**TITANIUM 8Al-Mo-IV CROSS BEAM REPAIR**

September 12, 1969

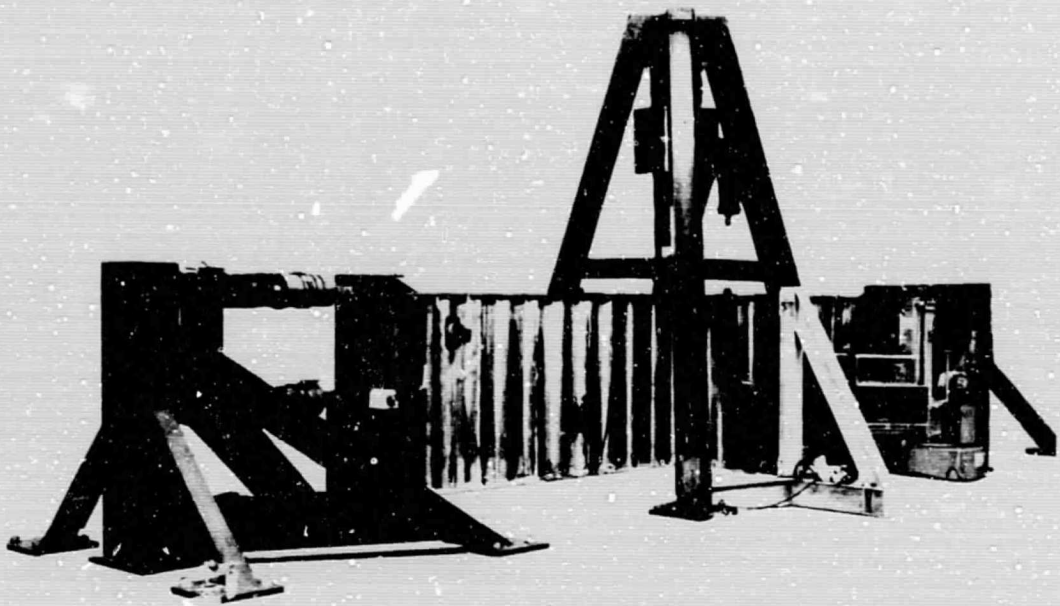
FIGURE 6. COMPLETE CROSSBEAM AND TESTING FIXTURE WITH ONLY ONE CYLINDER REMAINING

A method of repair was selected by joint action of the Propulsion and Vehicle Engineering and the Manufacturing Engineering Laboratories. The cable feed-through cylinders were removed by drilling a series of intersecting holes around each cylinder (Figs. 6 and 7.) Material for replacing the removed sections was obtained from test pieces of the 8-1-1 titanium alloy, formed to the sine wave configuration. This material was duplex annealed so that its metallurgical characteristics closely approximate those of the material in the cross-beam. The duplex annealing process is a heat treatment of 1003°K (1450° F) for 15 minutes followed by air cooling. This is in addition to the mill anneal.

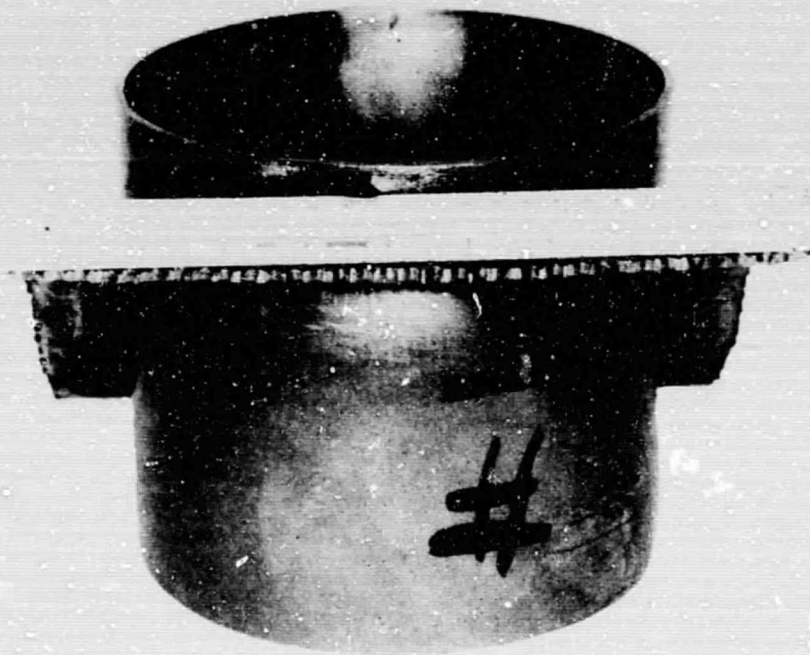
FIGURE 7. CABLE CYLINDER AS REMOVED FROM CROSSBEAM

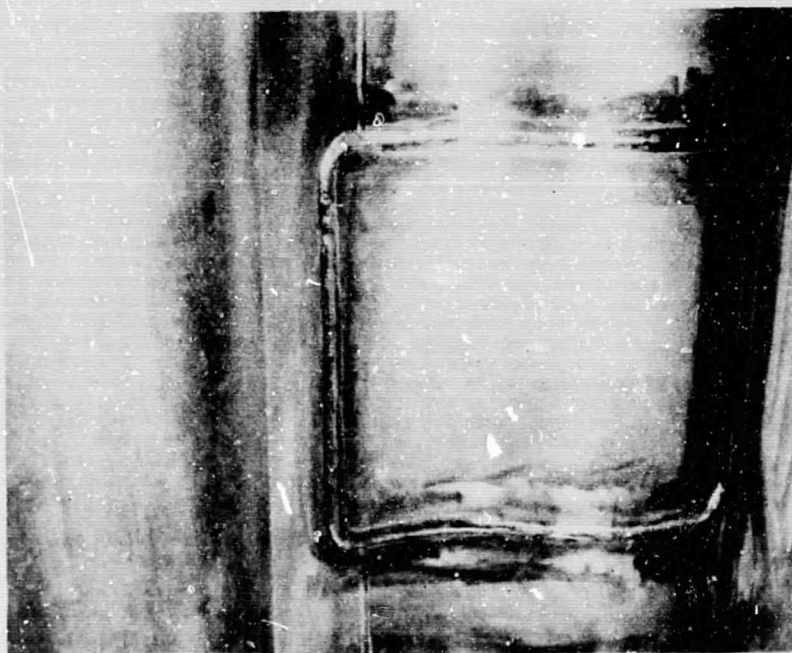
FIGURE 13. REPAIR PANEL NUMBER 3 WELDED INTO POSITION

Figures 11 through 15 show the finished repair panels and filler welds.
